DEFECTS AND FAILURES OF SOVIET STRUCTURES

REPORT NO. 94

Air Information Division, Structural Engineering Section

April 1958

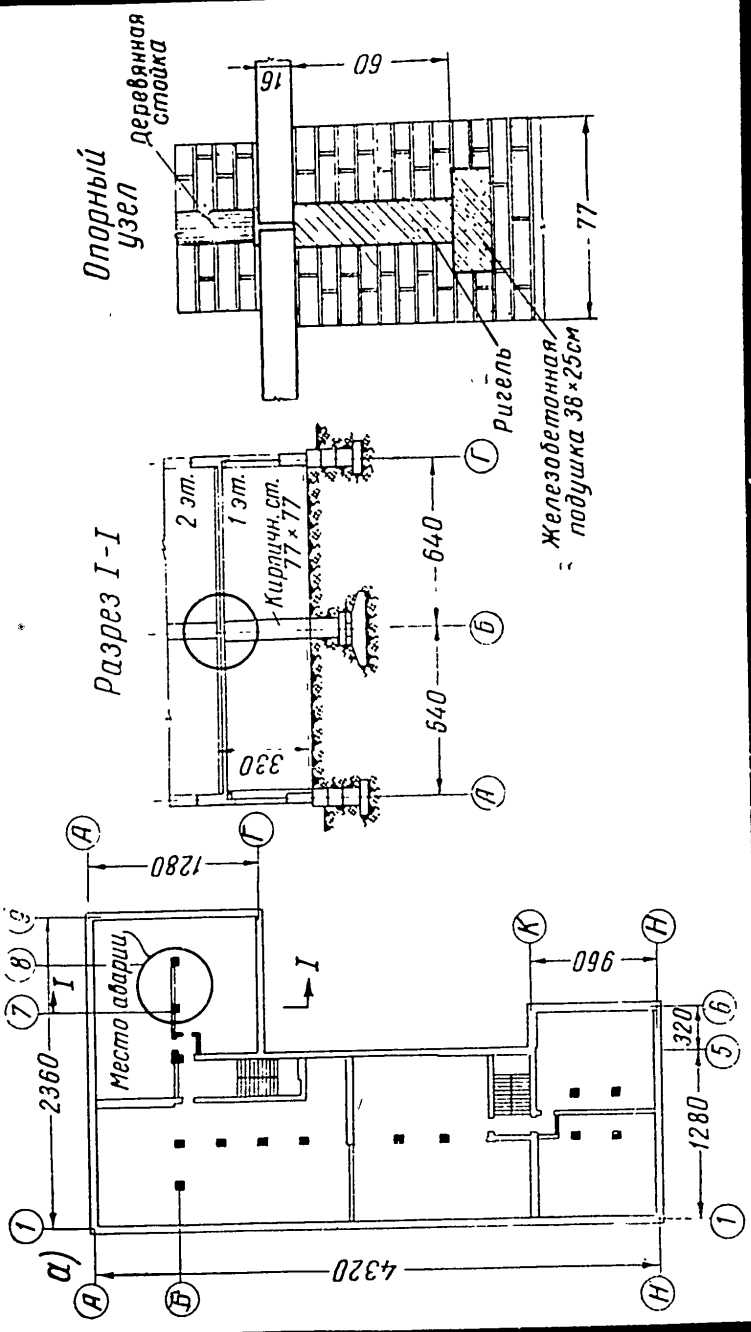
Pier-cross beam-floor slab joint. This joint is shown on Plate 1, fig. c. It should be noted that:

On 17 May 1956, the pier at the intersection of axes 8 and B (Plate 1, fig. a) apparently collapsed first, then the pier at the intersection of axes 7 and B. This was followed by the collapse of all pier and floor construction above them. In the middle bay between axes 7 and 8 everything went clear down to the ground; in two adjacent bays, the broken panels remained mostly suspended in the air, hanging by their reinforcement embedded in the walls. Because of the fall of the attic floor, the cornice brickwork was somewhat lifted, became warped and developed vertical and horizontal cracks. The beams were torn out of their wall joints, leaving holes in the walls. The outside walls, however, remained standing.

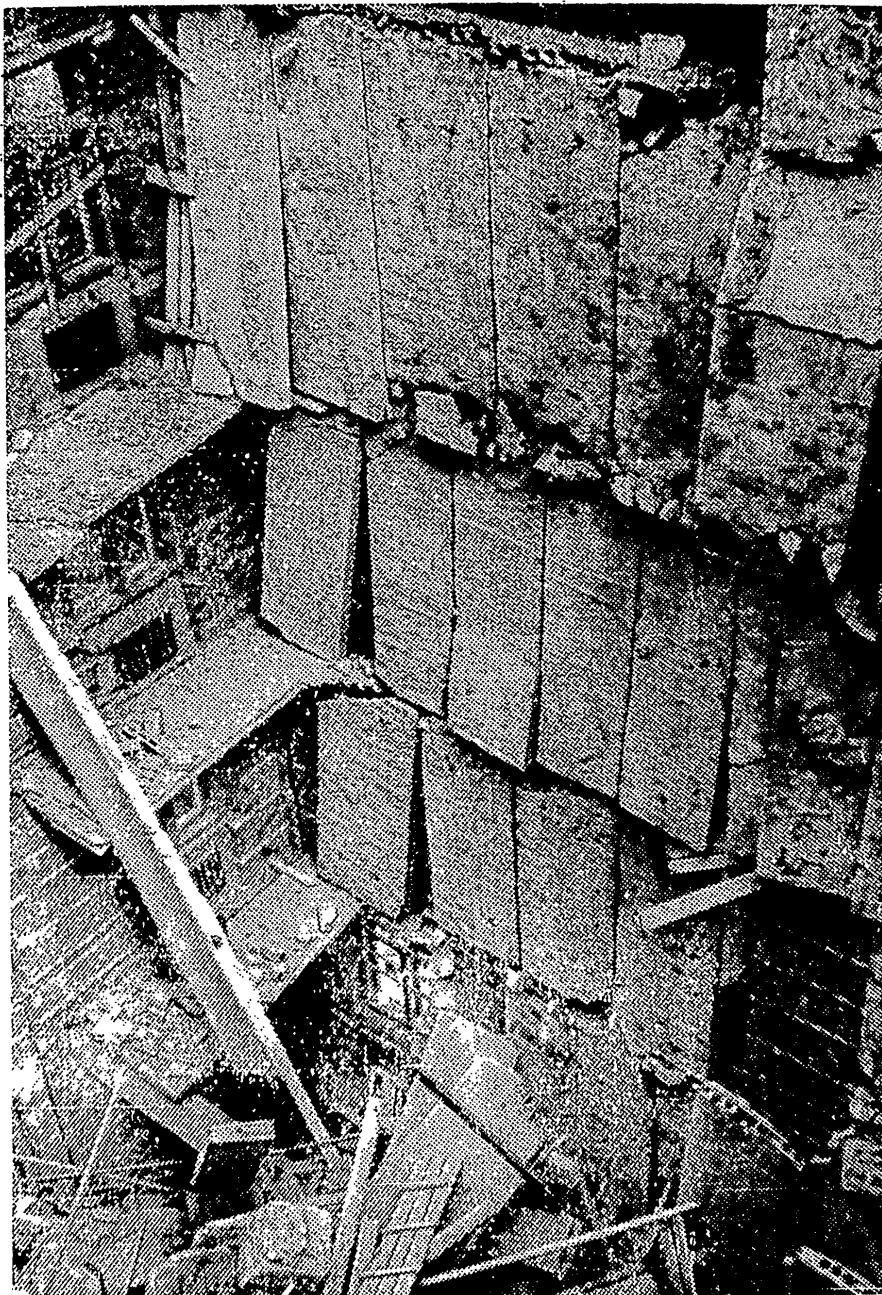
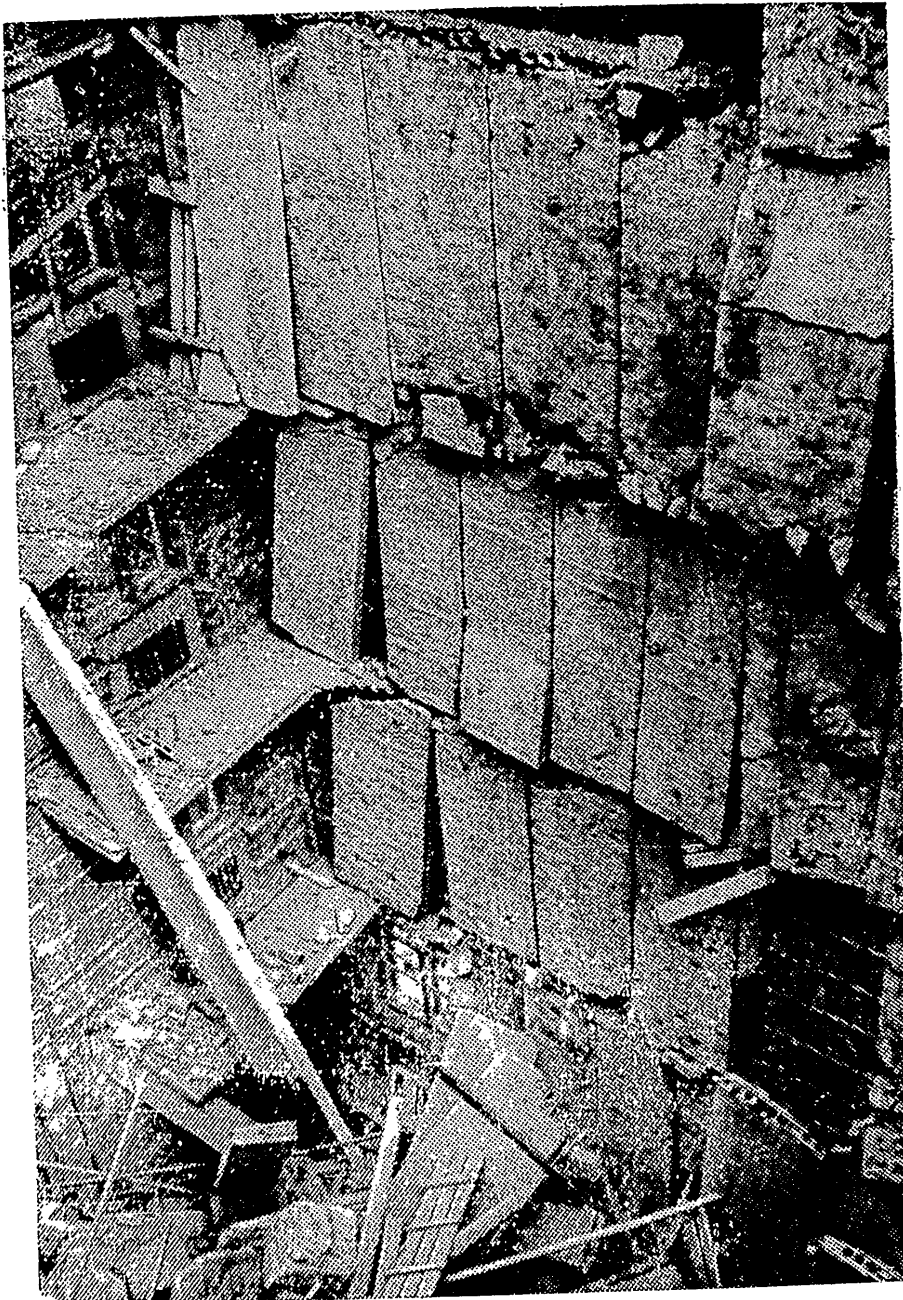
Photograph of the failure is shown on Plate 2.

Partial view of the collapsed structure.

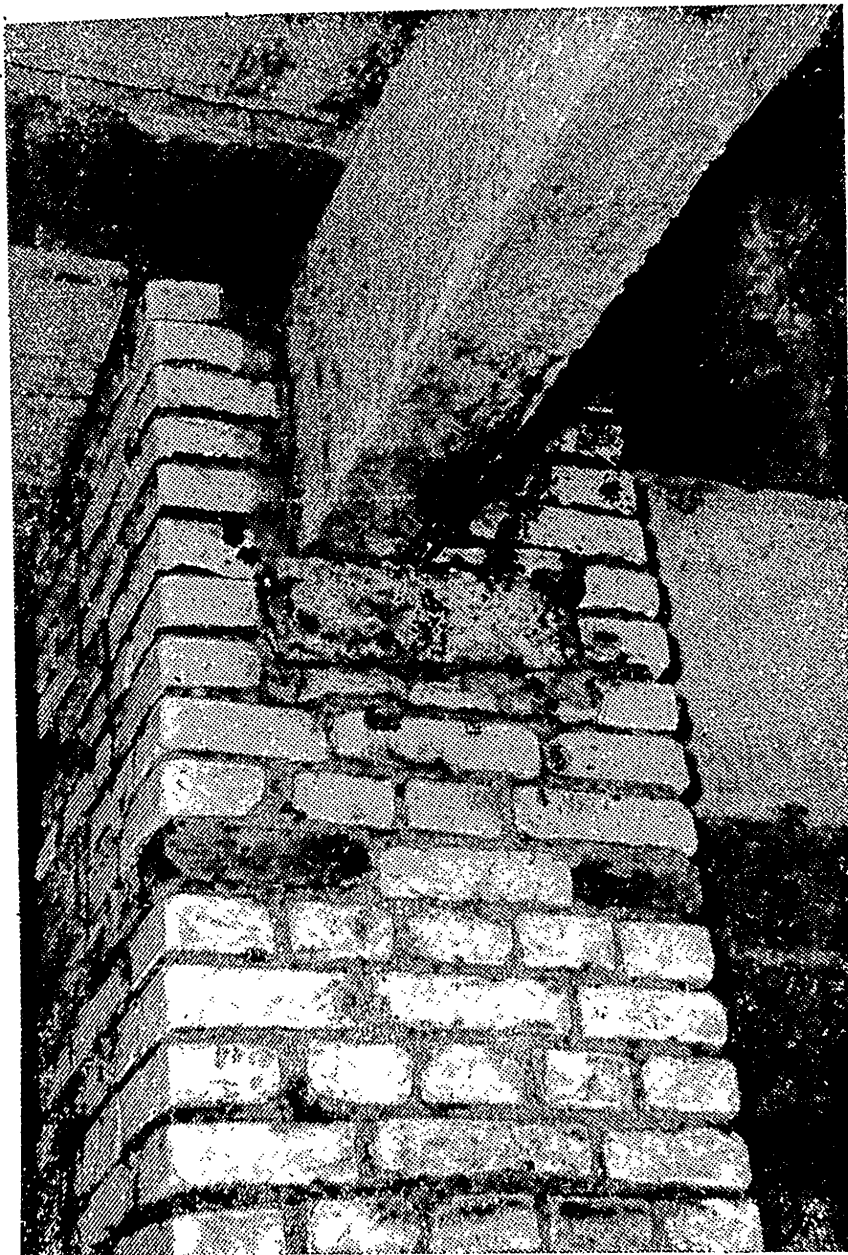
Eccentric beam-pier joint

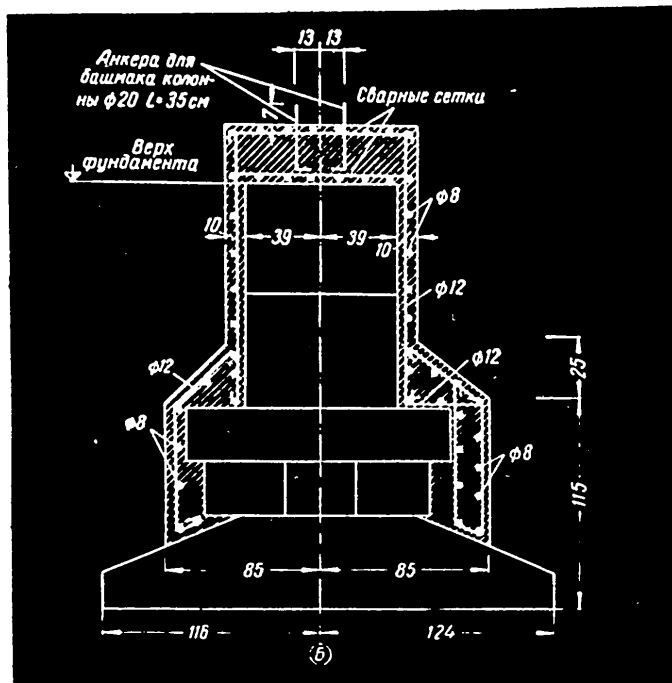
Strengthening of foundations with reinforced concrete casings.

The foundations above the footings were strengthened by reinforced concrete casings on the assumption that this would ensure a more uniform transfer of forces to the footings. Column anchor bolts were embedded in the upper part of the casing.

Vertical section of a strengthened foundation is shown on Plate 4.

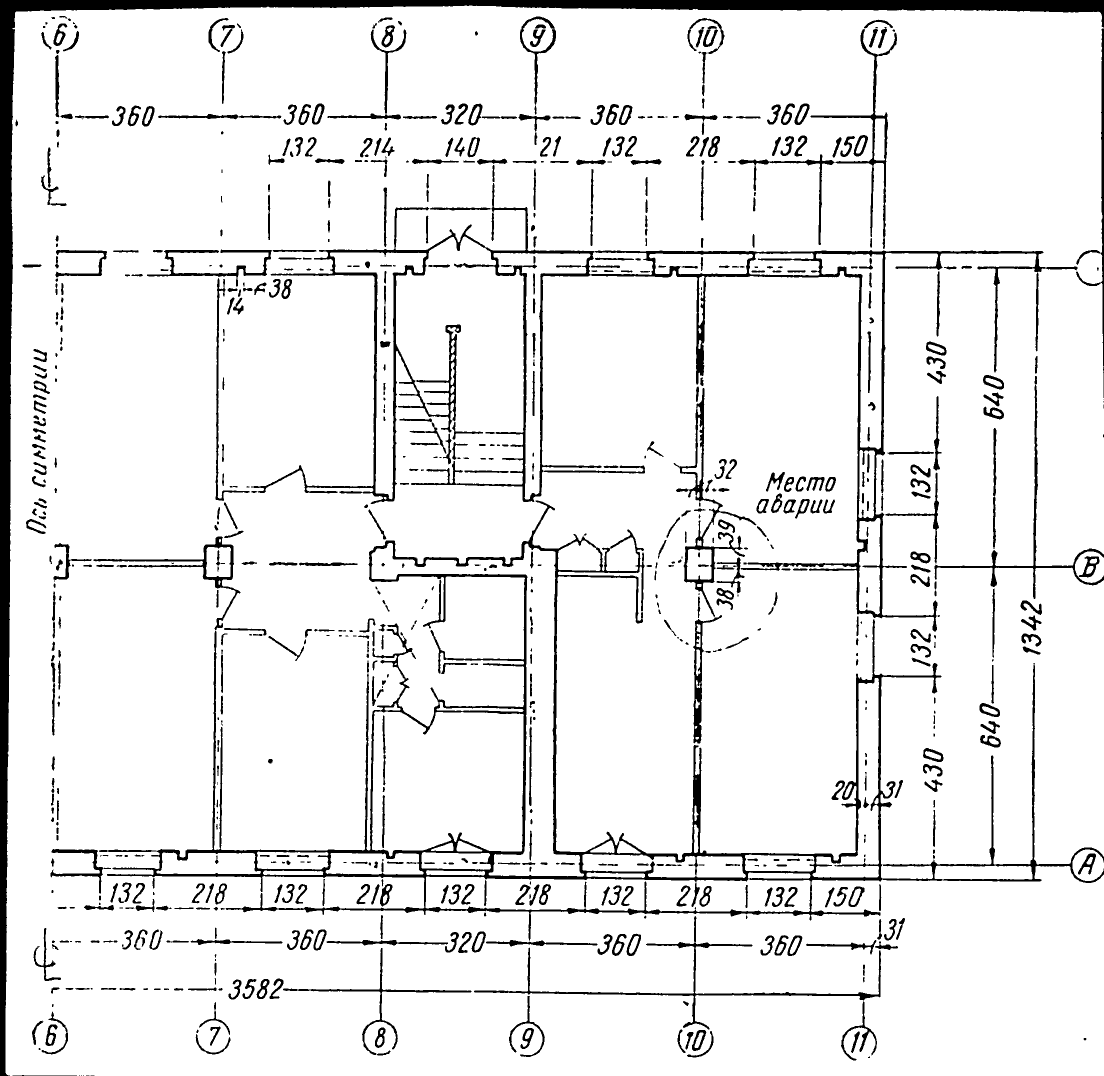
Plan of the 1st floor (Standard design, Series P-01-13)
The collapsed pier is marked with a circle

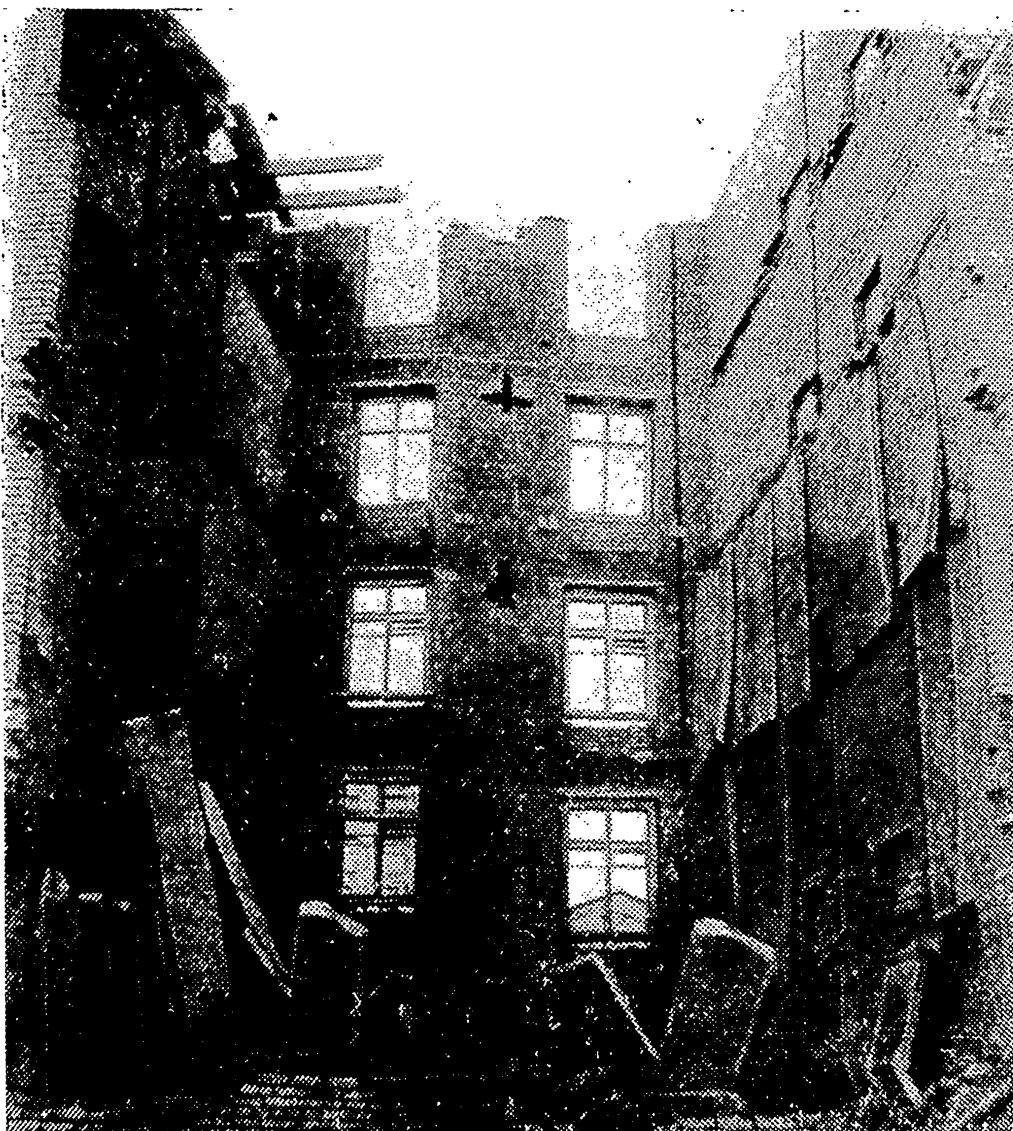
General view of the collapsed part of the structure.

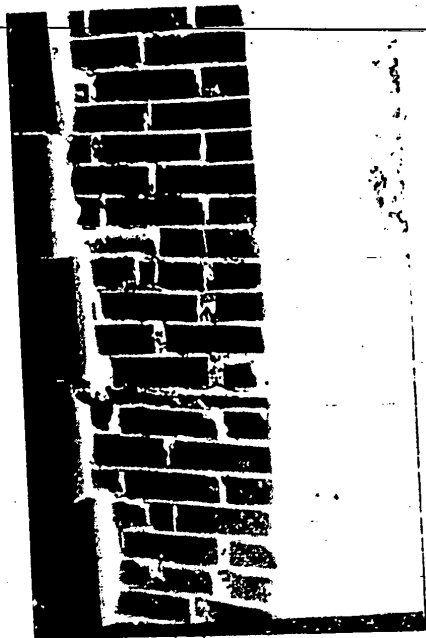
Fig. 1. Pier similar to those which collapsed. Top of a hollow ceramic brick may be seen in the brickwork.

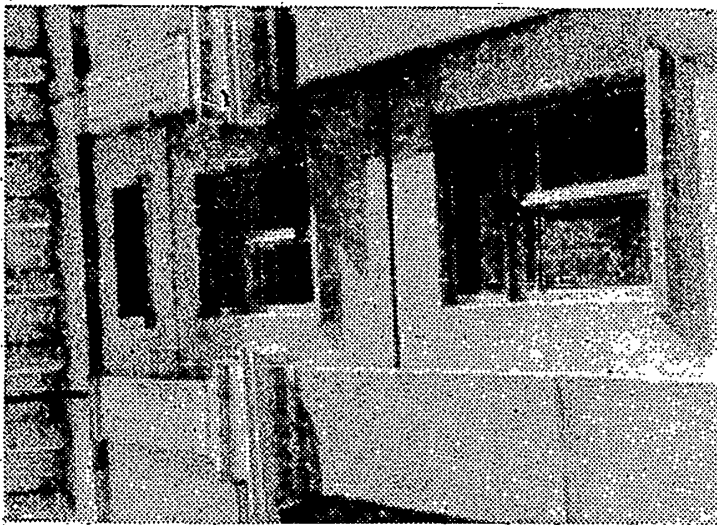
Fig. 1. Crack in the cornice

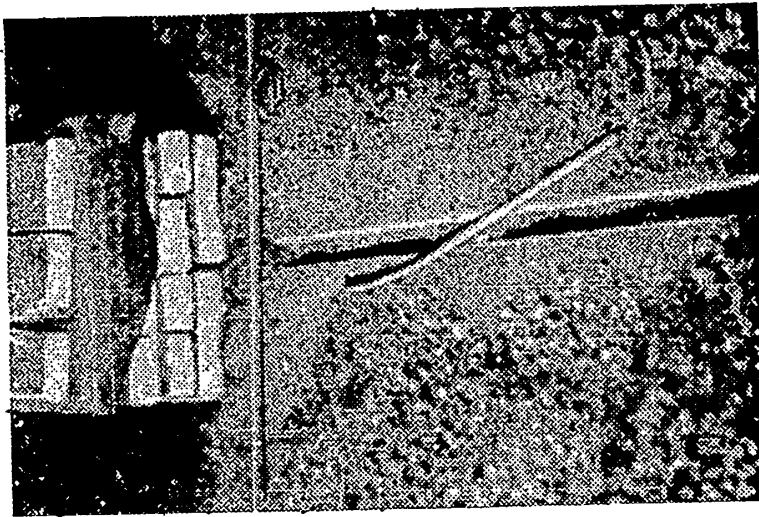
Fig. 2. Separation of slabs in the attic floor

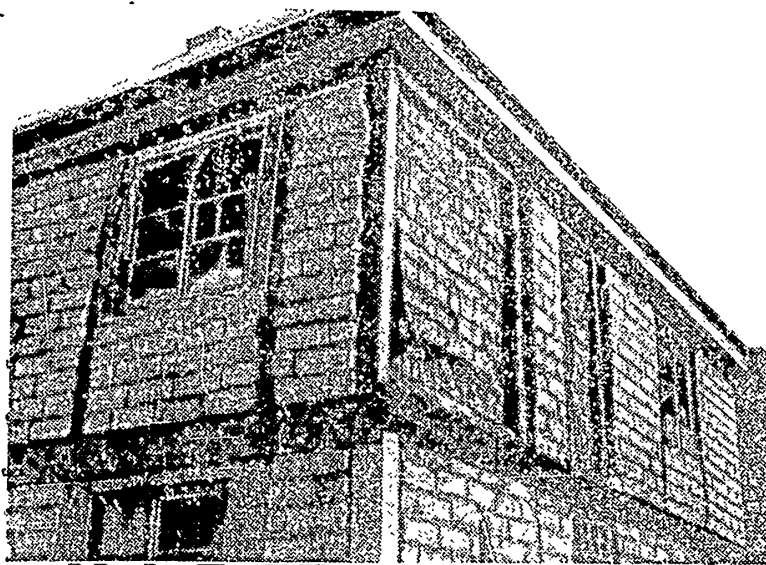
Fig. 2. Incipient disintegration of lime-diatomite block walls 2-4 years after erection.

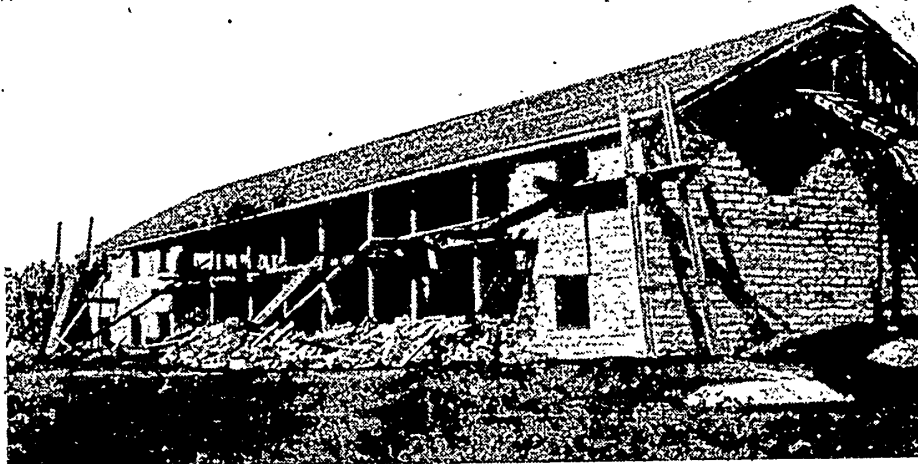
Fig. 1. Disintegration of the structure 3-4 years after erection

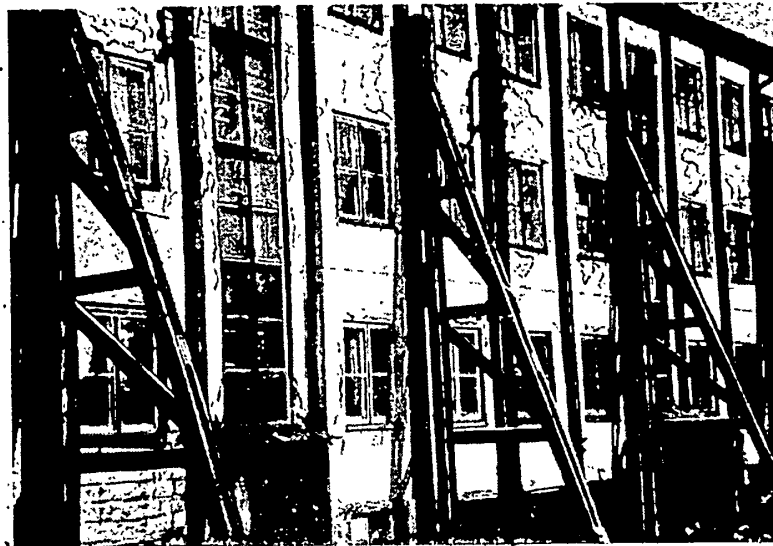
Fig. 1. Outside appearance of a 3-story lime-diatomite structure at Sverdlovsk 25 years after erection (the walls were shored a few years after erection)

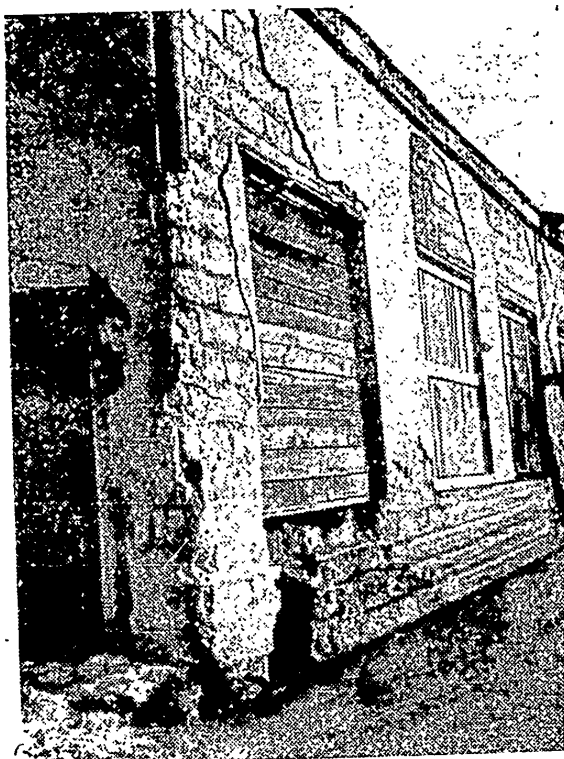
Fig. 1. Disintegration of a corner of a store caused by excessive moisture; (part of a broken drain pipe appears at the upper left corner)

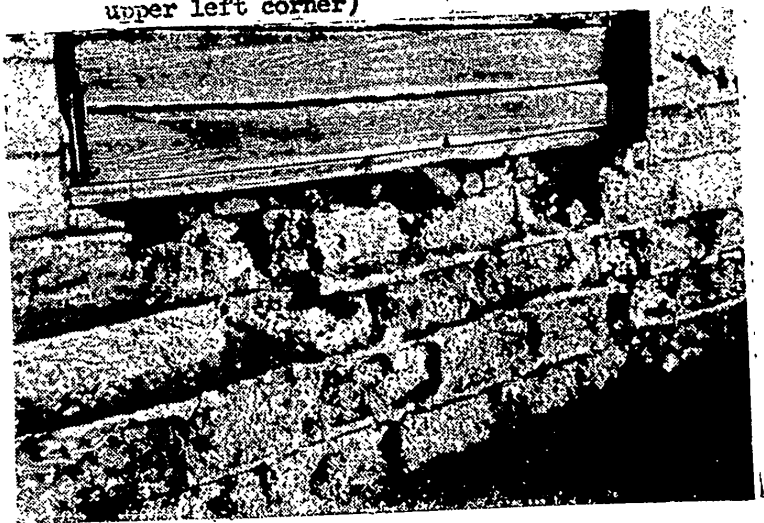
Fig. 2. Disintegration of blocks under window

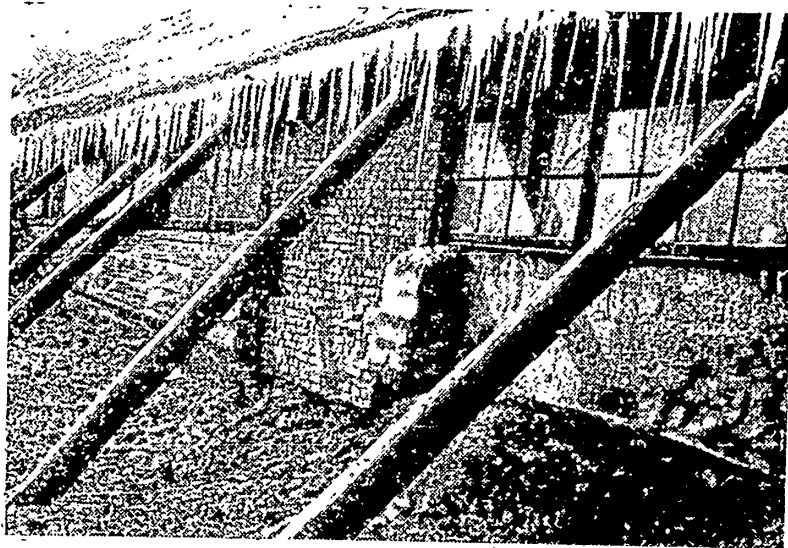
Fig. 1. Disintegration of a wall in a boiler house; (part of the block wall was replaced with brick; logs took place of disintegrated buttresses)

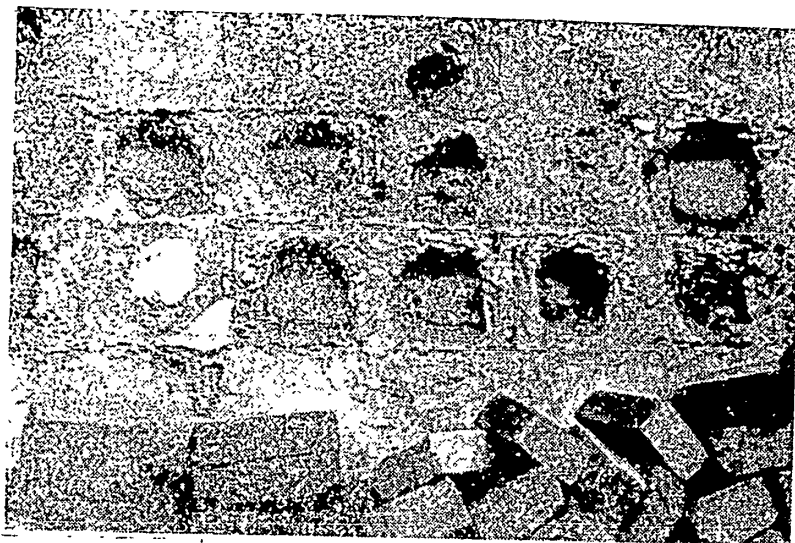
Fig. 2. Disintegration of the inside face of a wall in a dry industrial shop. (Shop operational conditions could have contributed to the damage).

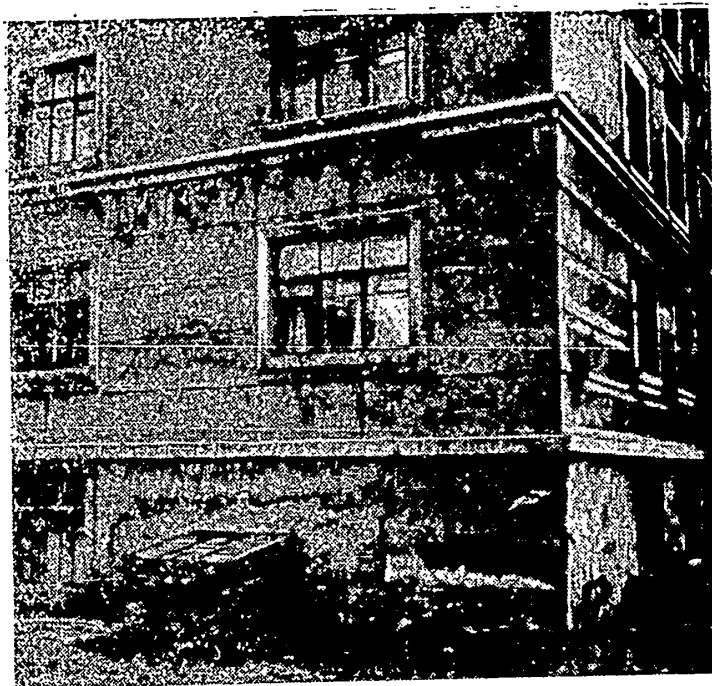
Fig. 1. Corner of a house built at Magnitogorsk in 1934 of large lime-slag blocks. Condition of the structure except the plinth is stated to be satisfactory.

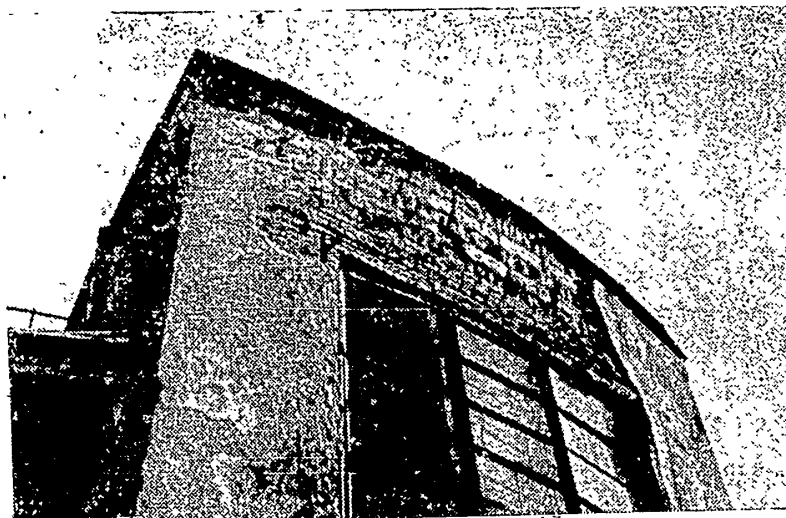
Fig. 2. Disintegration of a lime-diatomite block wall caused by weathering. The narrow eaves provide no protection from moisture.

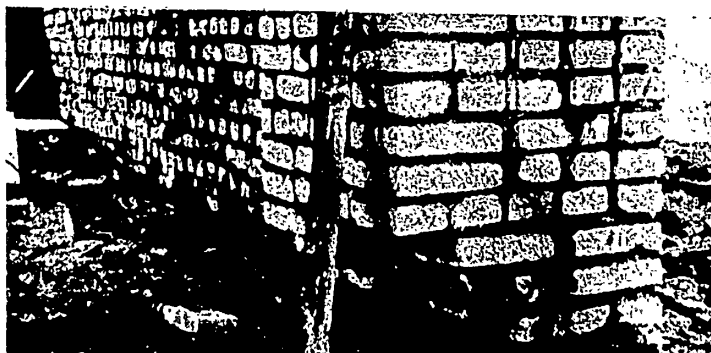
Fig. 4. Reinforced concrete panel with disintegrating load-bearing rib

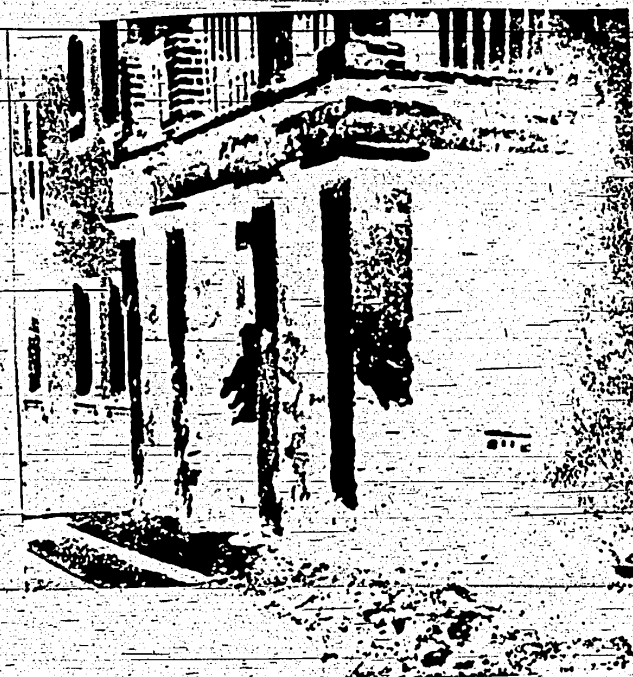
Fig. 1. "Two years after the housewarming the tenants had to be moved out. The house was disintegrating."

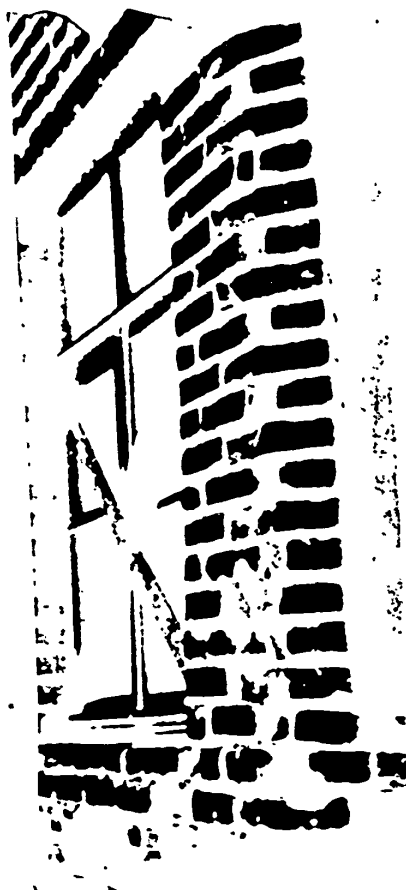
Fig. 1. "House No. 18 in block 3 was built by Trust No. 114. Defects of such brickwork could only be hidden under a thick layer of plaster."

Fig. 2. "Cracks appeared in the concrete plinth and brickwork because of the settlement of foundations. (Built by Trust No. 114)."

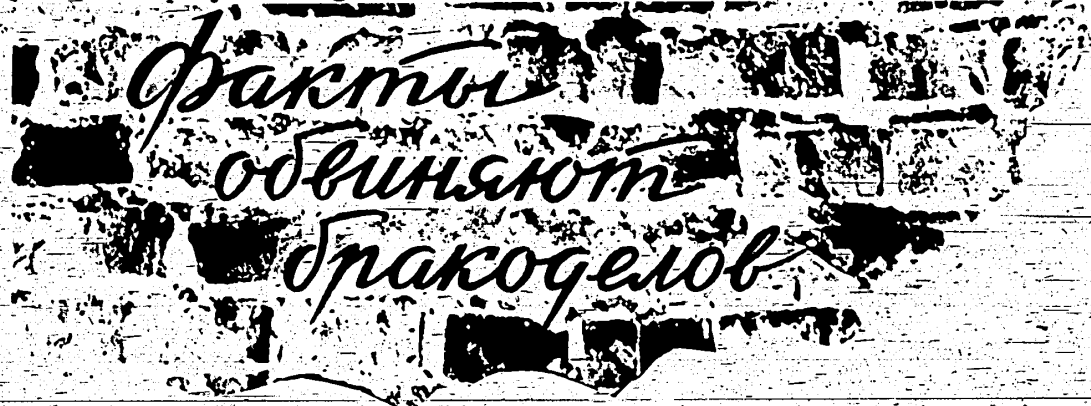
Fig. 1. "This brickwork was built by 'Krivorozhstroy' Trust".

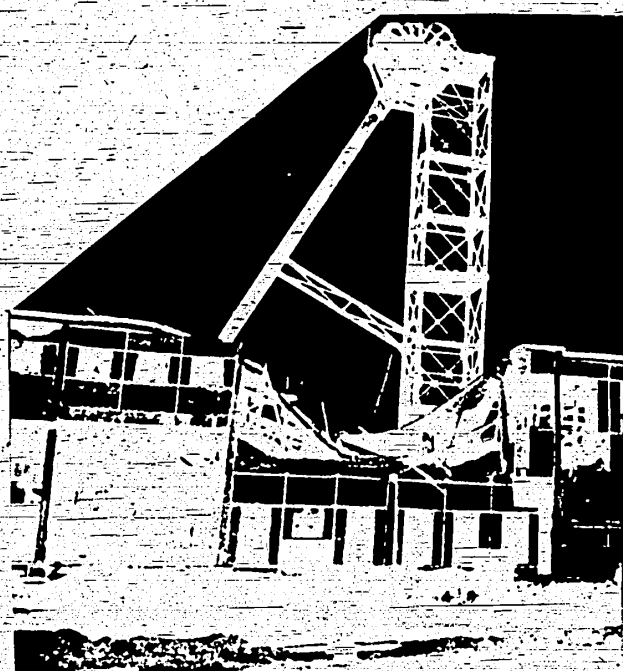
Fig. 2. "The collapse of loading bunkers, trestles and reloading stations at Krinichanskaya-Severnaya mine in Donbass was due to the poor quality of concrete in columns; (built by 'Kadievshakhstroy' Trust)".

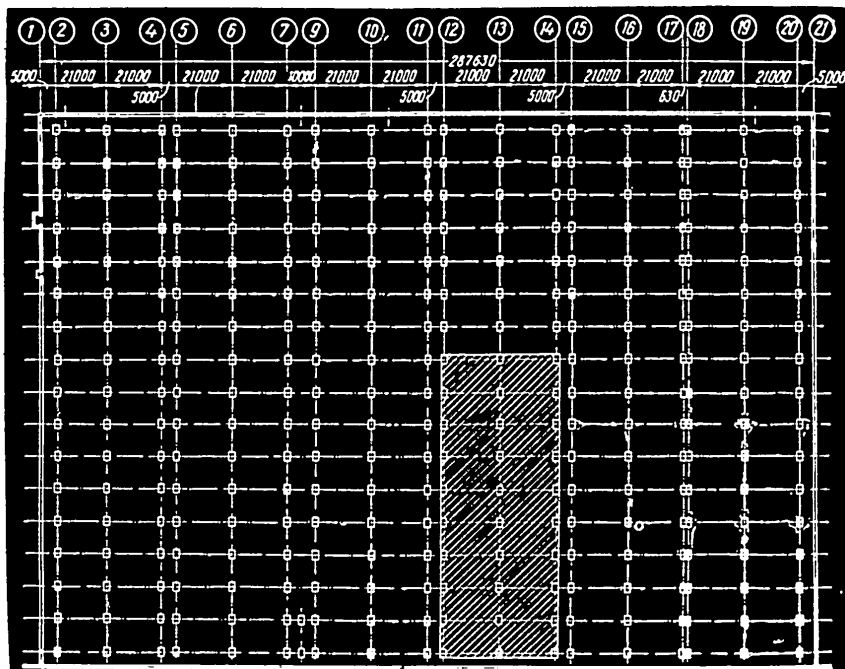
Fig. 1. Plan of the plant. Shaded area indicates the part that collapsed.

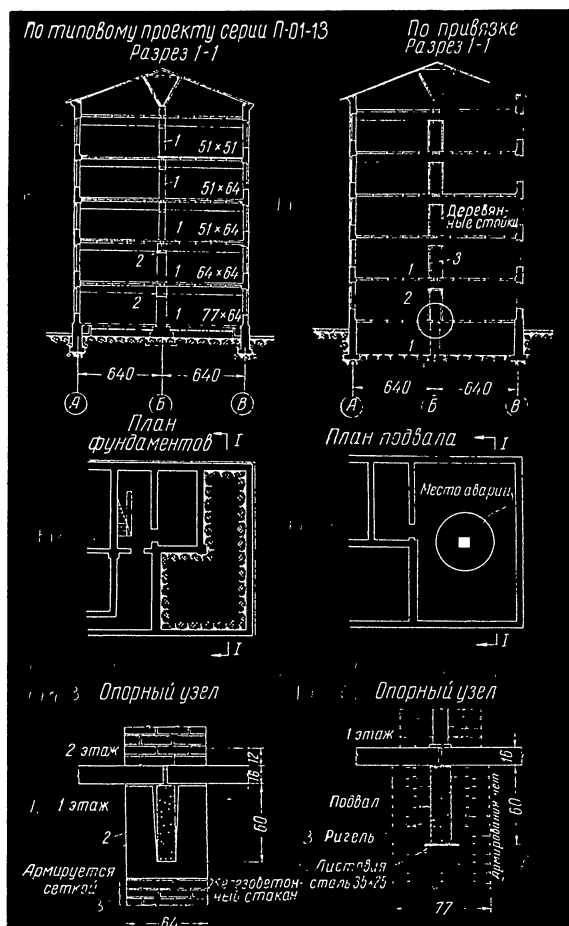
Figs. 1,2,3 - Structure as designed; Figs. 4,5,6 - Structure as actually built.
Sections and details of the structure
The collapsed pier is marked with a circle.

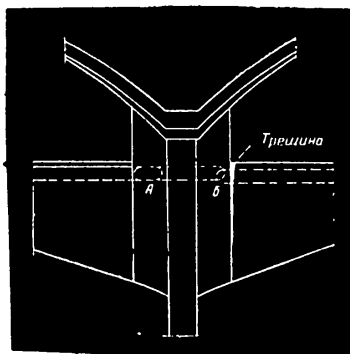
Fig. 2. Crack in a Perederiy tie beam-column joint
A. Normal position of reinforcement loops in the joint
B. Shifted loops in the joint

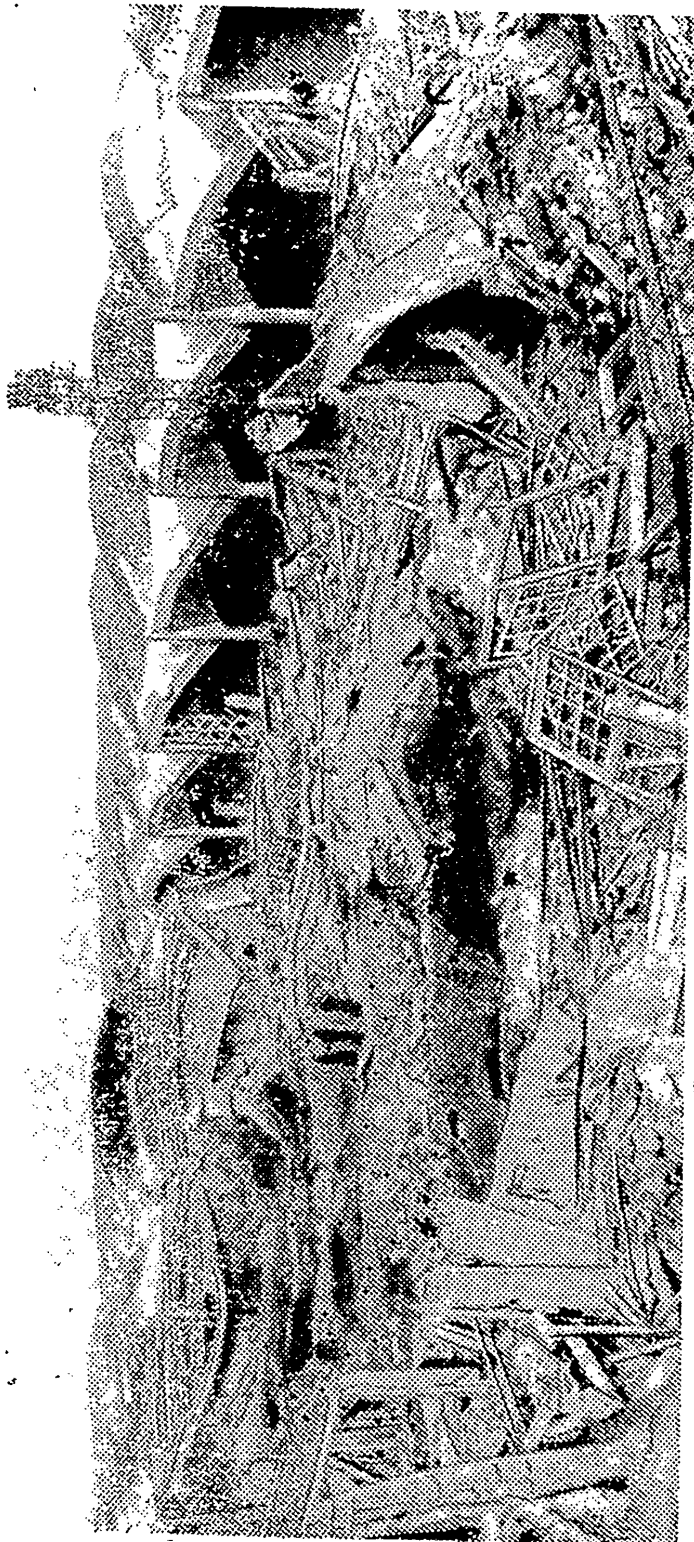
General view of the collapsed part of the plant

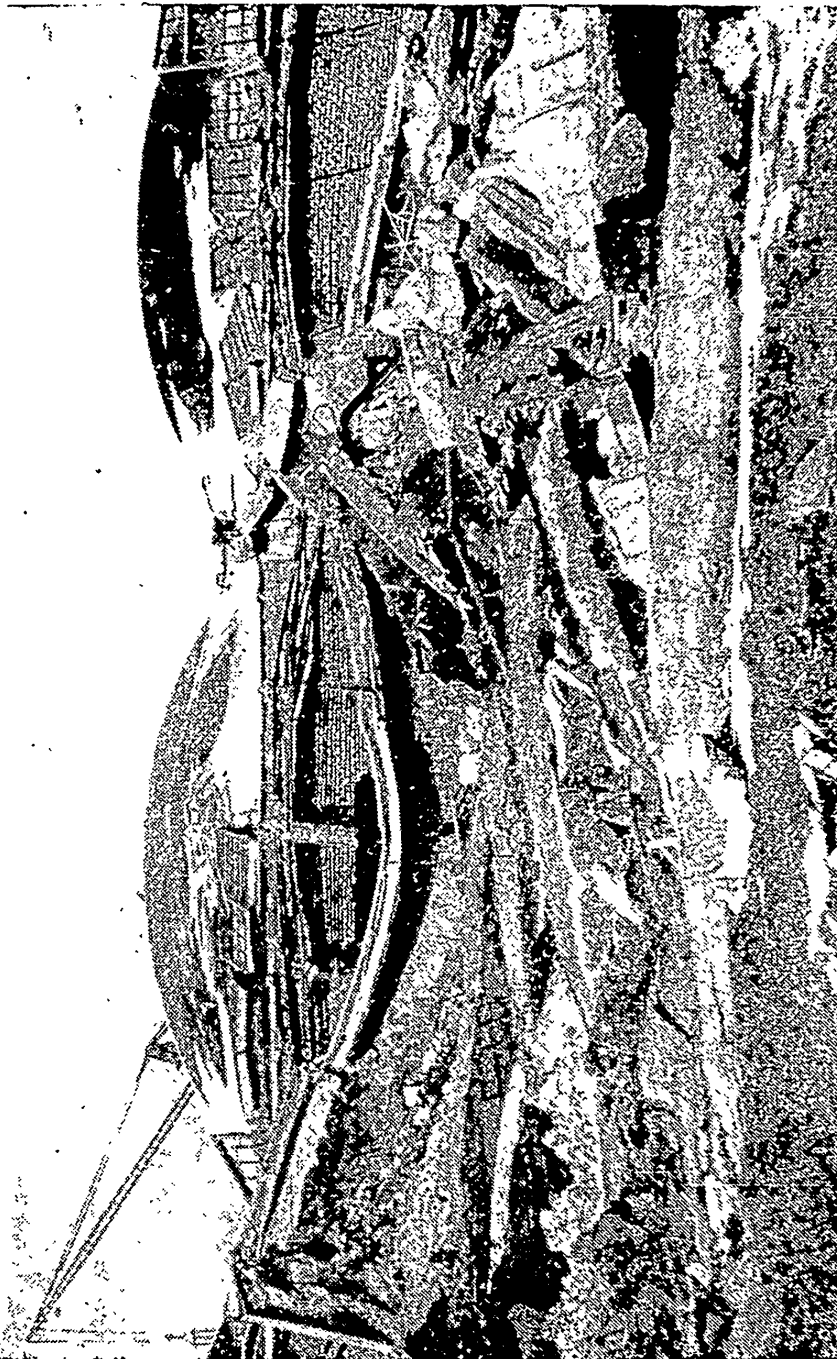
General view of the debris. The brick partition that stopped the chain collapse is seen in the background

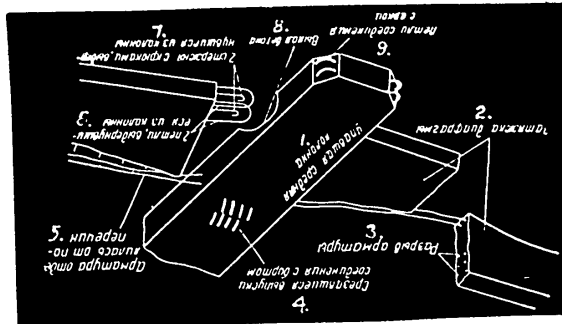
Fig. 1. Position of the column and tie beam in the bay where failure started
 1. Fallen middle column. 2. Tie beam. 3. Ruptured reinforcement.
 4. Remnants of sheared off reinforcement. 5. Reinforcement separated from stirrups. 6. Two loops torn out of the column. 7. Two bars torn out of the column. 8. Broken concrete. 9. Column-arch joint loops.
 (Note that lettering on drawing is inverted)

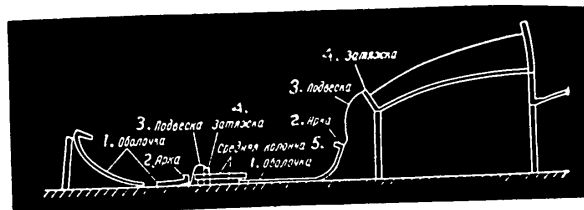
Fig. 2. Chain collapse. Relative position of various structural members
 1. Roof shell. 2. Arch. 3. Suspension support. 4. Tie beam.
 5. Middle column.

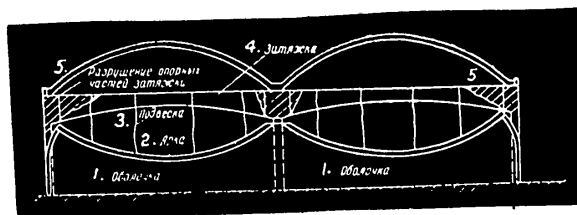
Fig. 3. Shell failure at the brick partition which stopped chain collapse
 1. Shell. 2. Arch. 3. Hanger. 4. Tie beam. 5. Damaged tie beam ends

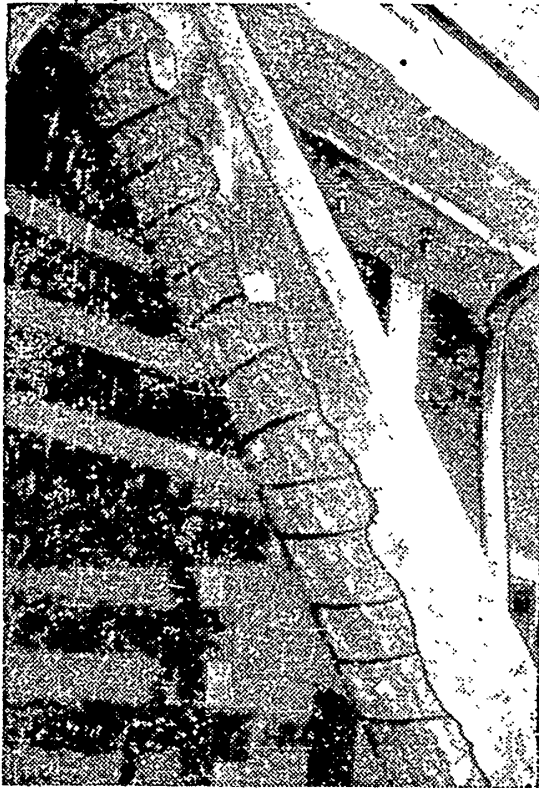
Fig. 1. Effects of frost

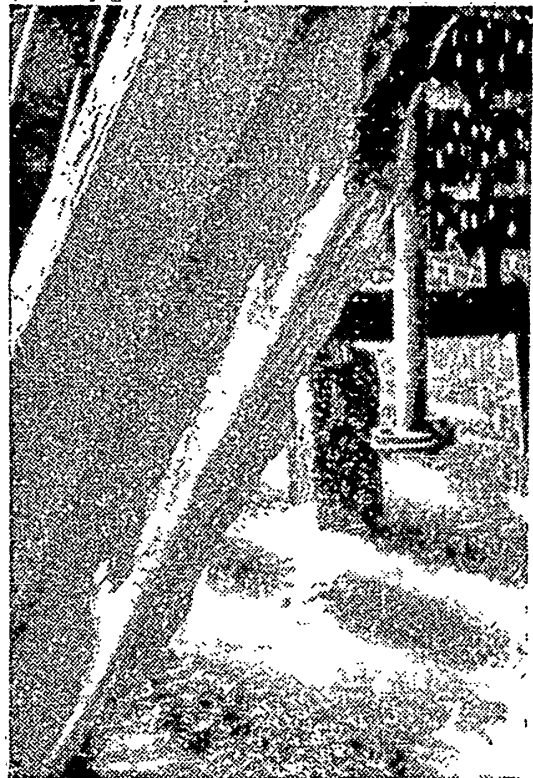
Fig. 2. Crumbling concrete;
calcium carbonate
deposits

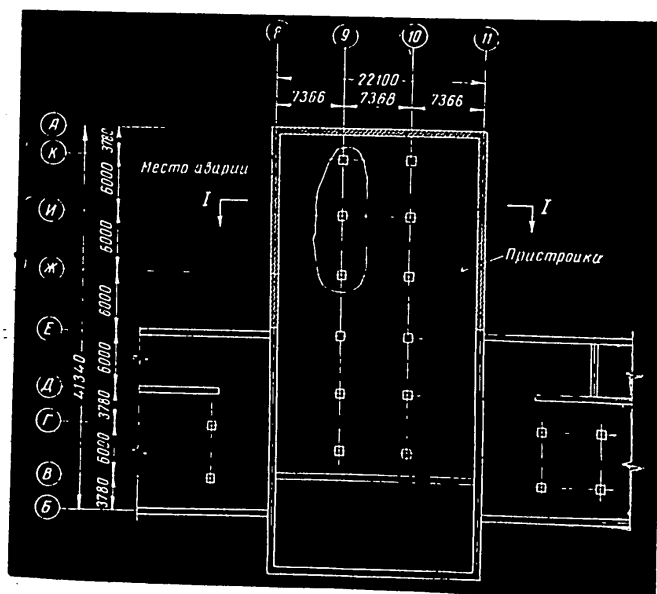
a) The new wing. b) Piers that failed
Plan of the Structure

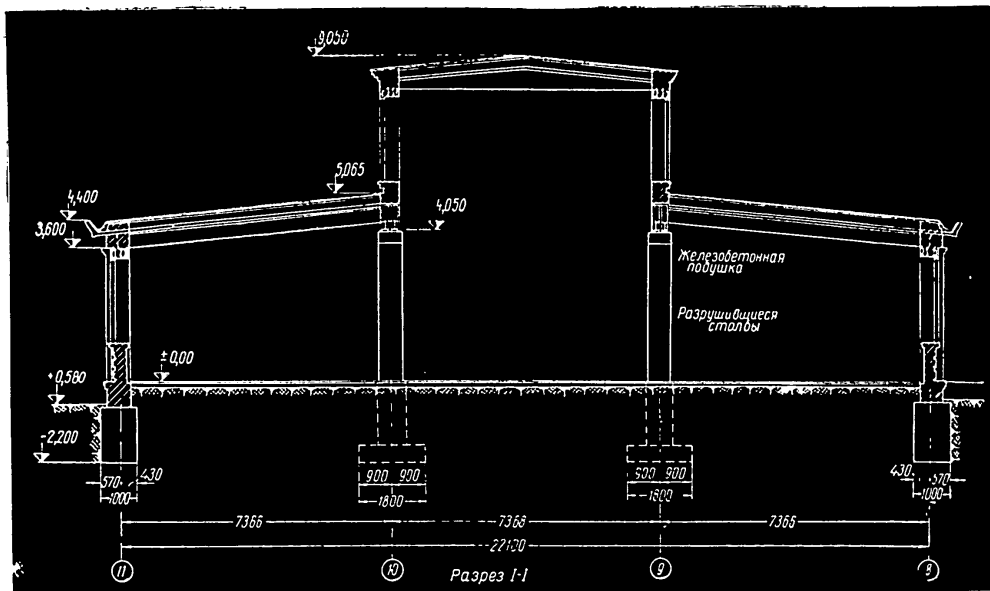
1. RC bearing pad. 2. Collapsed piers
Section 1-1

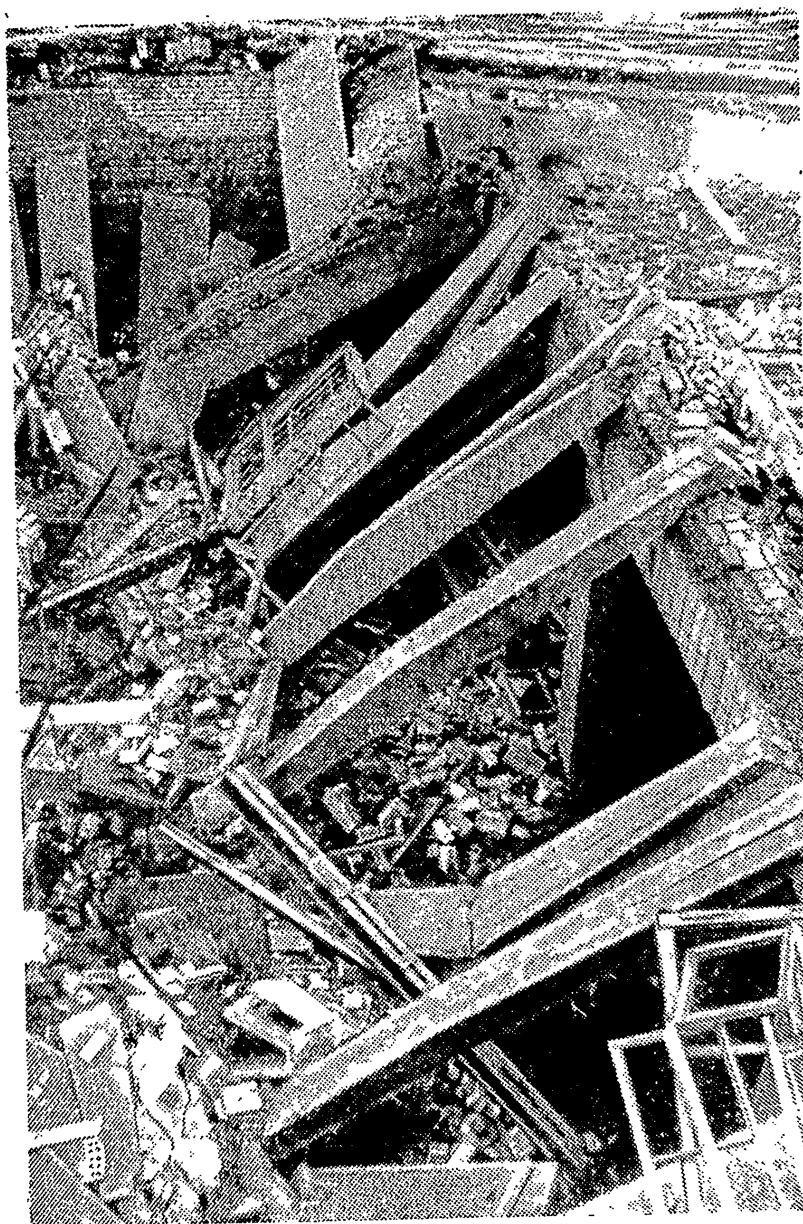
General view after the collapse

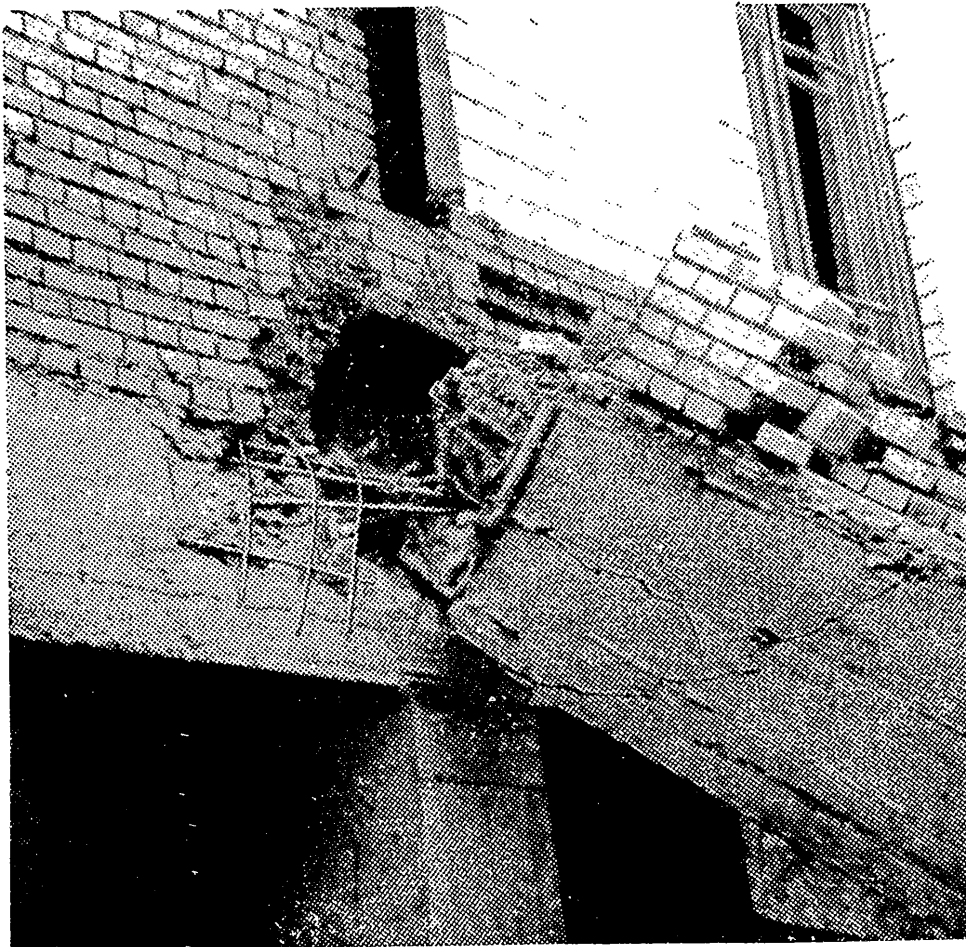
Failure of a beam-pier joint
